BDCR AGM June 2017
Technical Report

NORDTANK

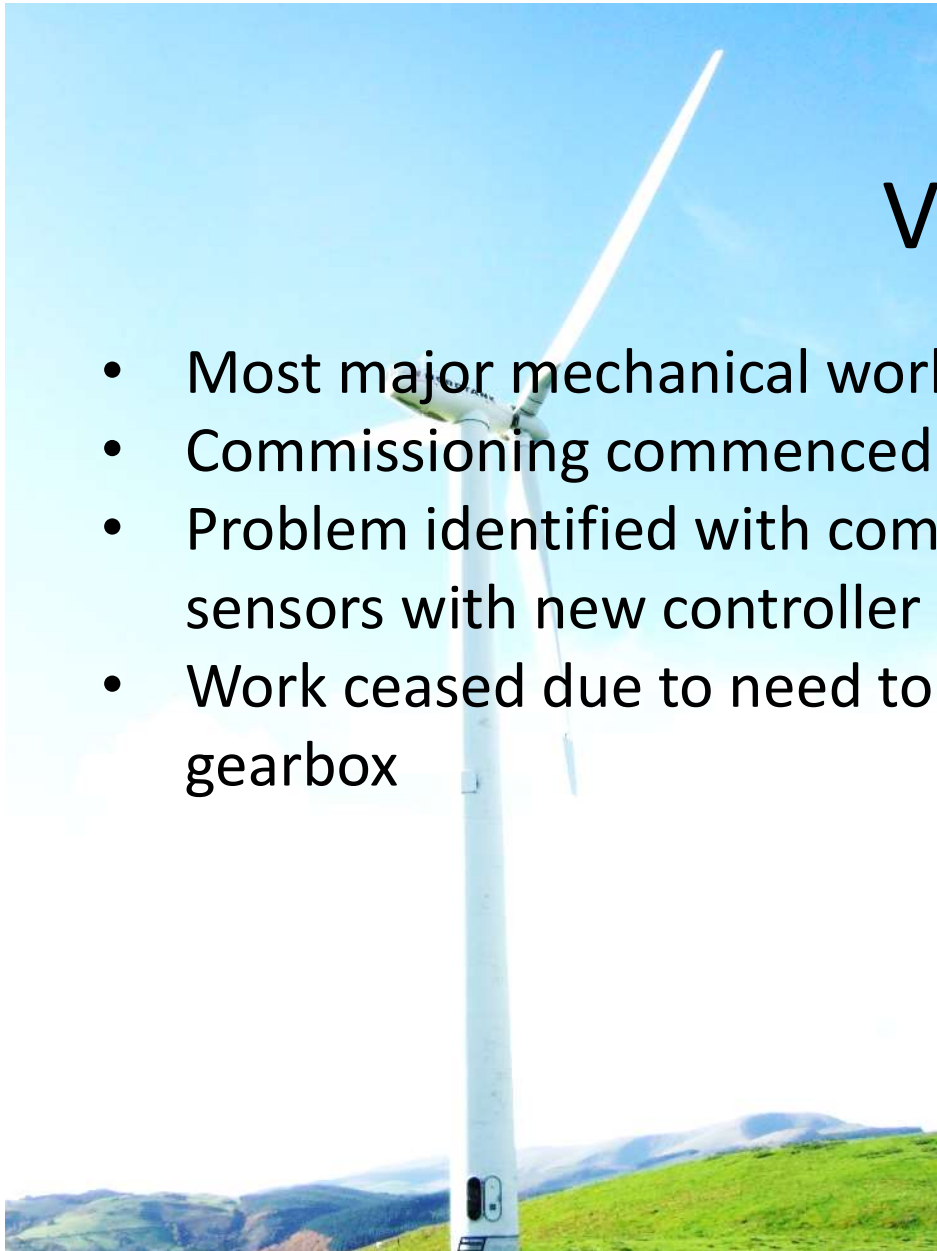
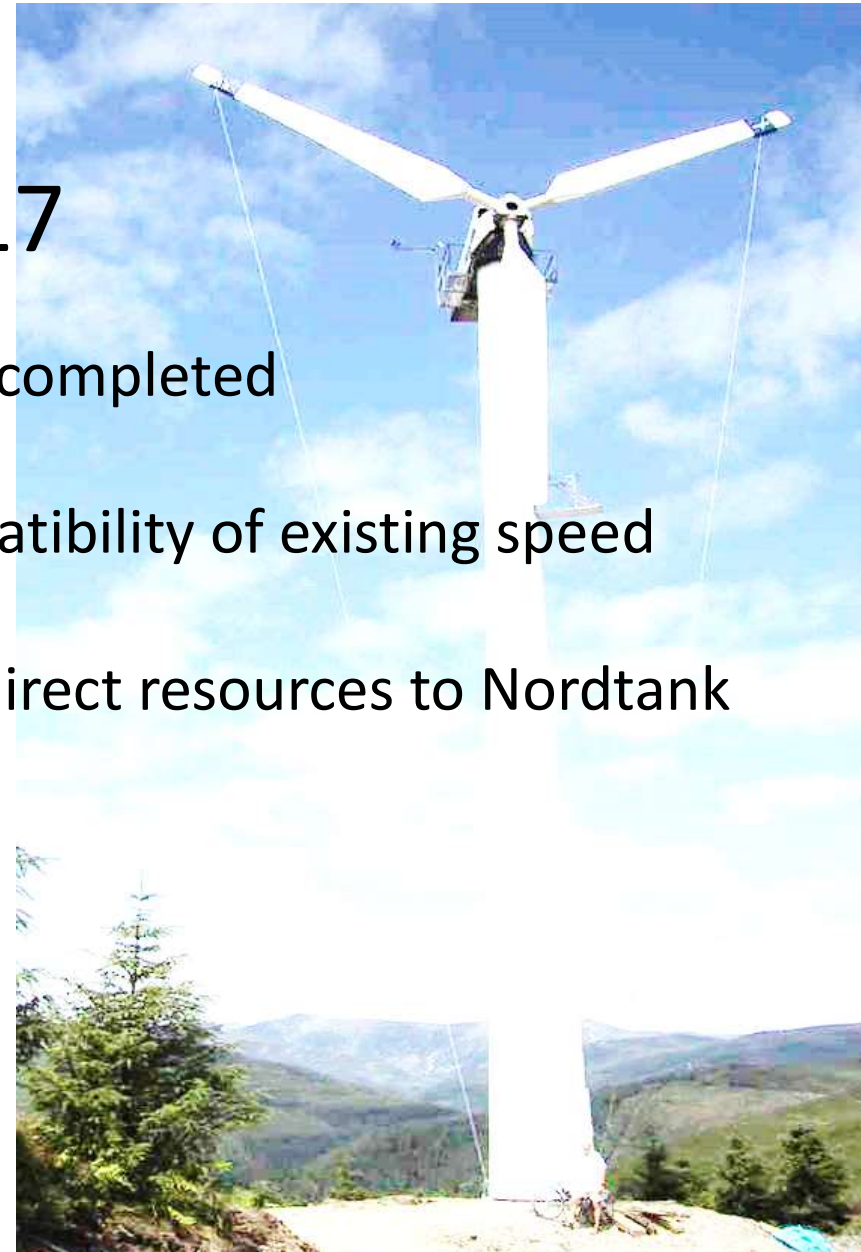
V17

- Most major mechanical work completed
- Commissioning commenced
- Problem identified with compatibility of existing speed sensors with new controller
- Work ceased due to need to direct resources to Nordtank gearbox

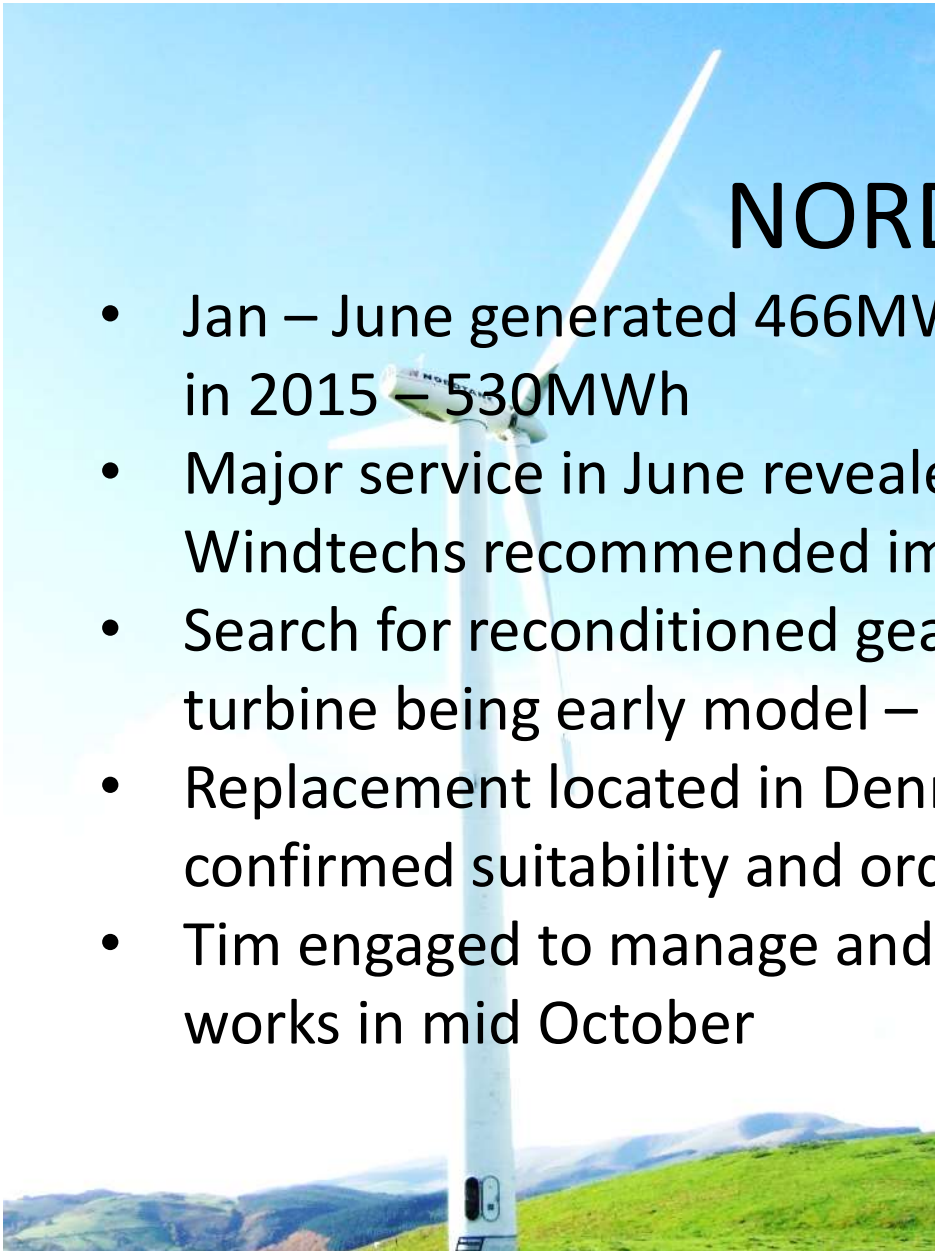
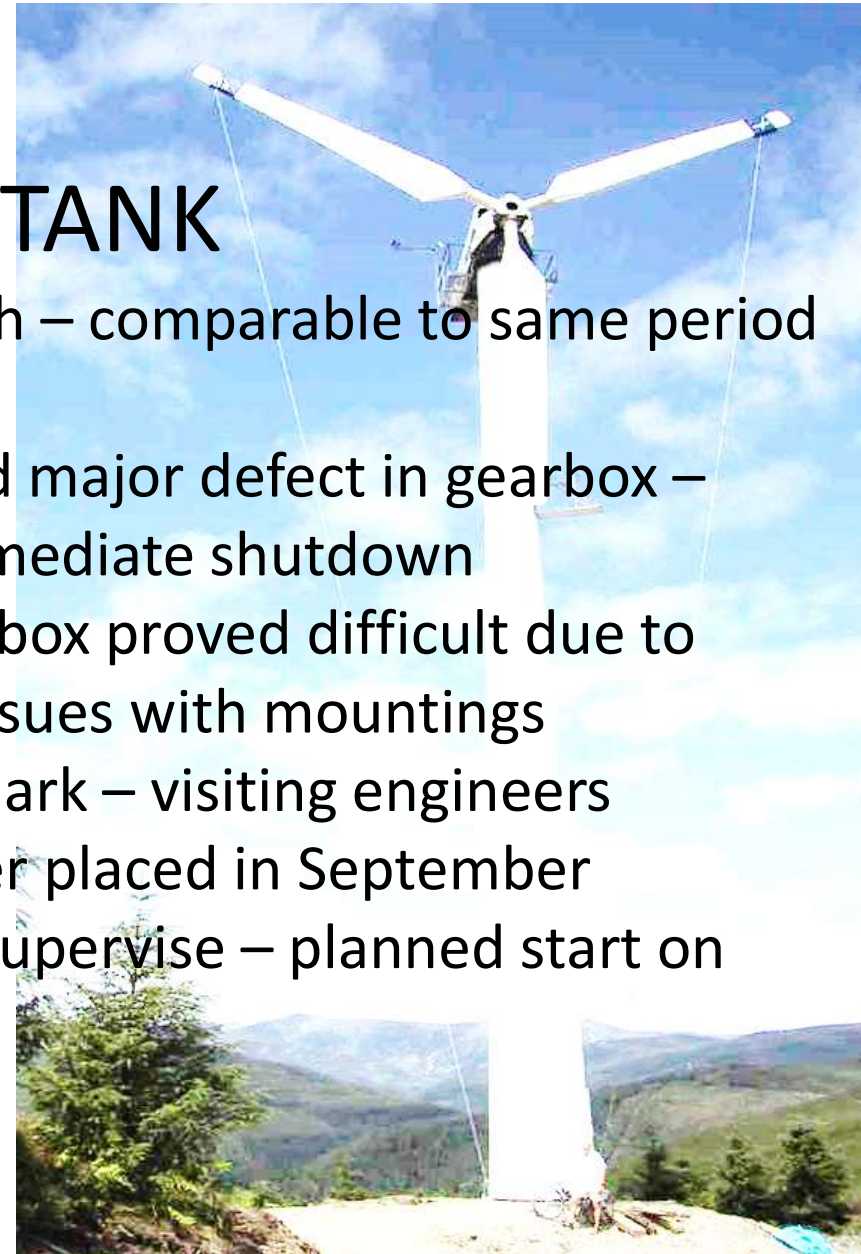
- Jan – June generated 466MWh – comparable to same period in 2015 – 530MWh
- Major service in June revealed major defect in gearbox – Windtechs recommended immediate shutdown
- Search for reconditioned gearbox proved difficult due to turbine being early model – issues with mountings
- Replacement located in Denmark – visiting engineers confirmed suitability and order placed in September
- Tim engaged to manage and supervise – planned start on works in mid October

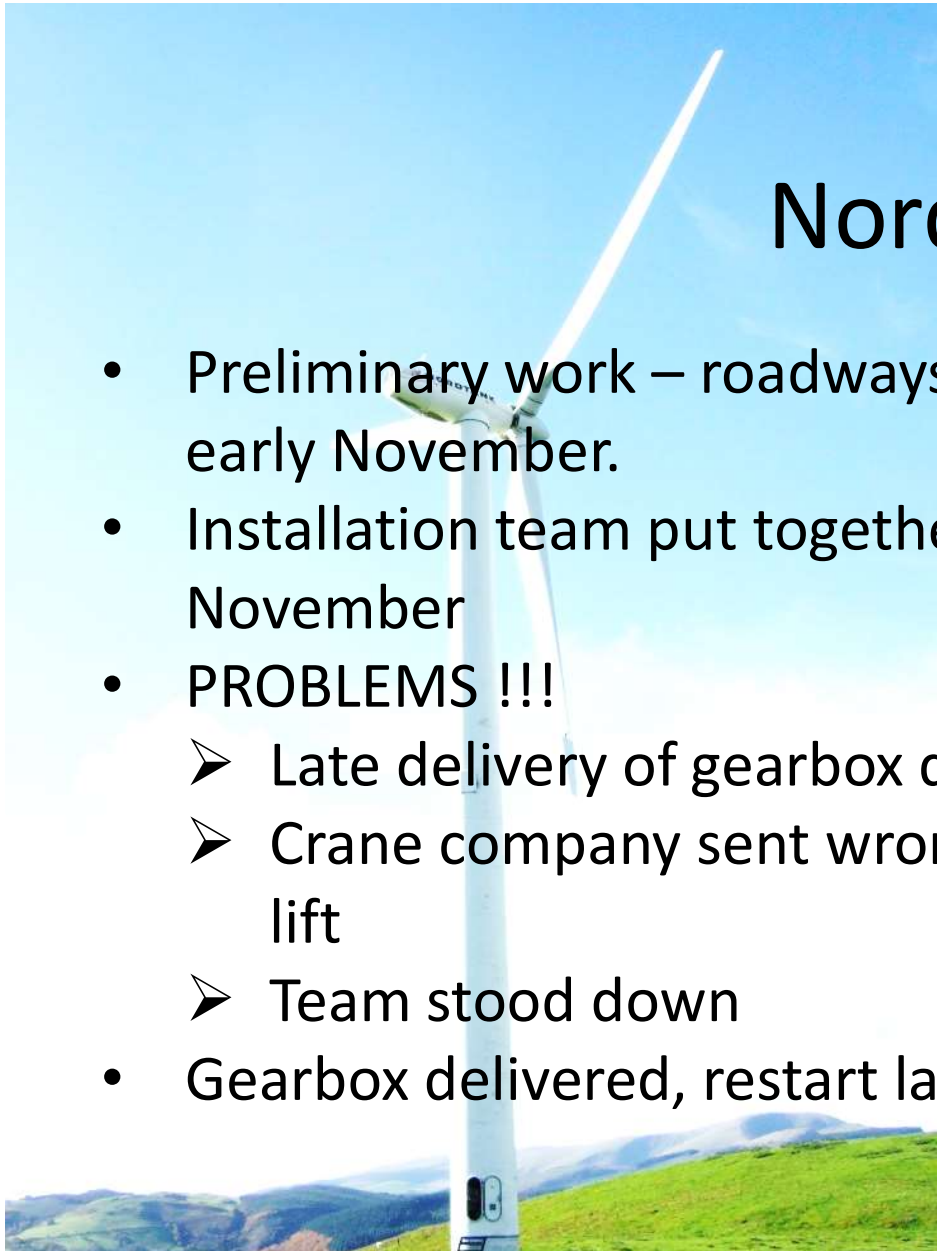
Nordtank

- Preliminary work – roadways, hardstanding etc completed by early November.
- Installation team put together for work to commence in early November
- **PROBLEMS !!!**
 - Late delivery of gearbox due to delays in docks/customs
 - Crane company sent wrong capacity crane- too small for lift
 - Team stood down
- Gearbox delivered, restart late November

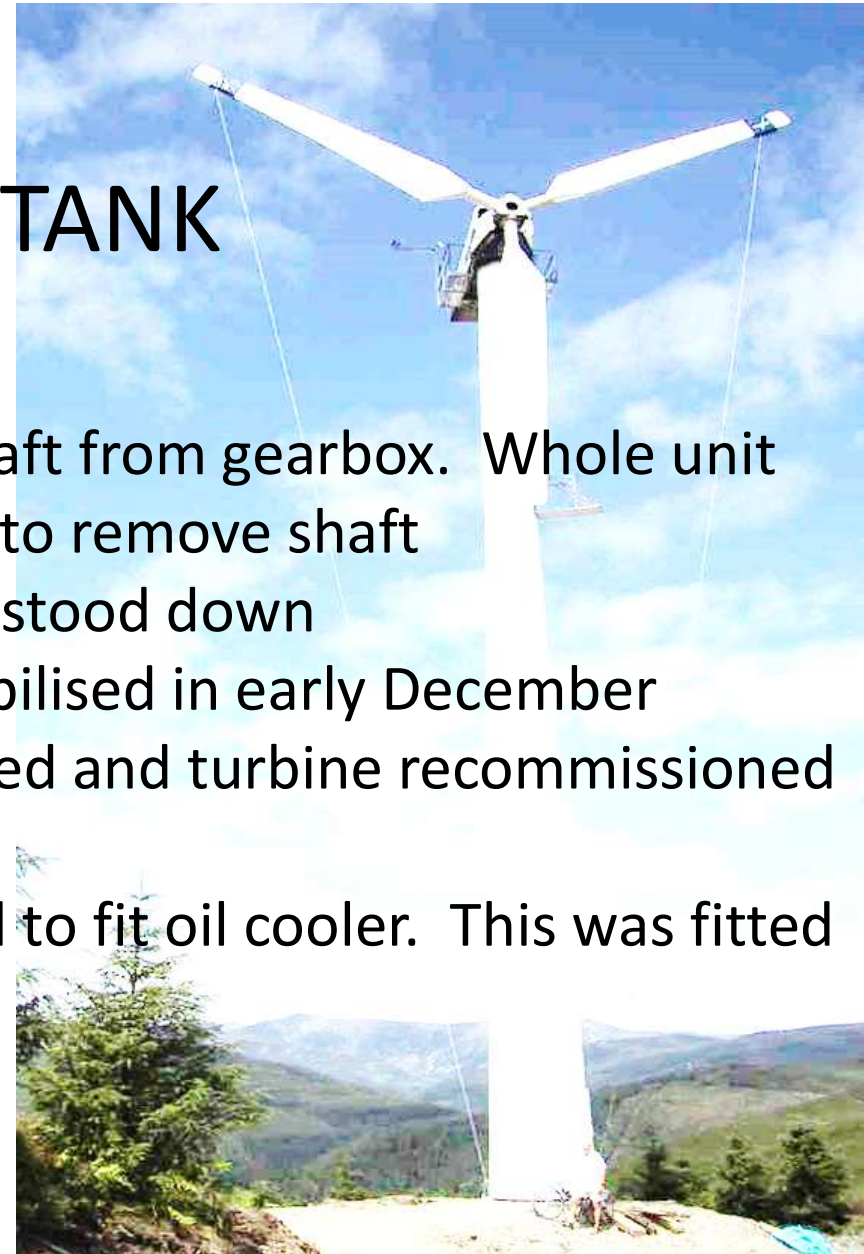
NORDTANK

- PROBLEMS !!!
 - Unable to remove main shaft from gearbox. Whole unit removed – but still unable to remove shaft
 - New shaft ordered – team stood down
- Shaft arrived and team remobilised in early December
- SUCCESS ! Gearbox re-installed and turbine recommissioned by mid December
- Back in operation, but needed to fit oil cooler. This was fitted in early 2017

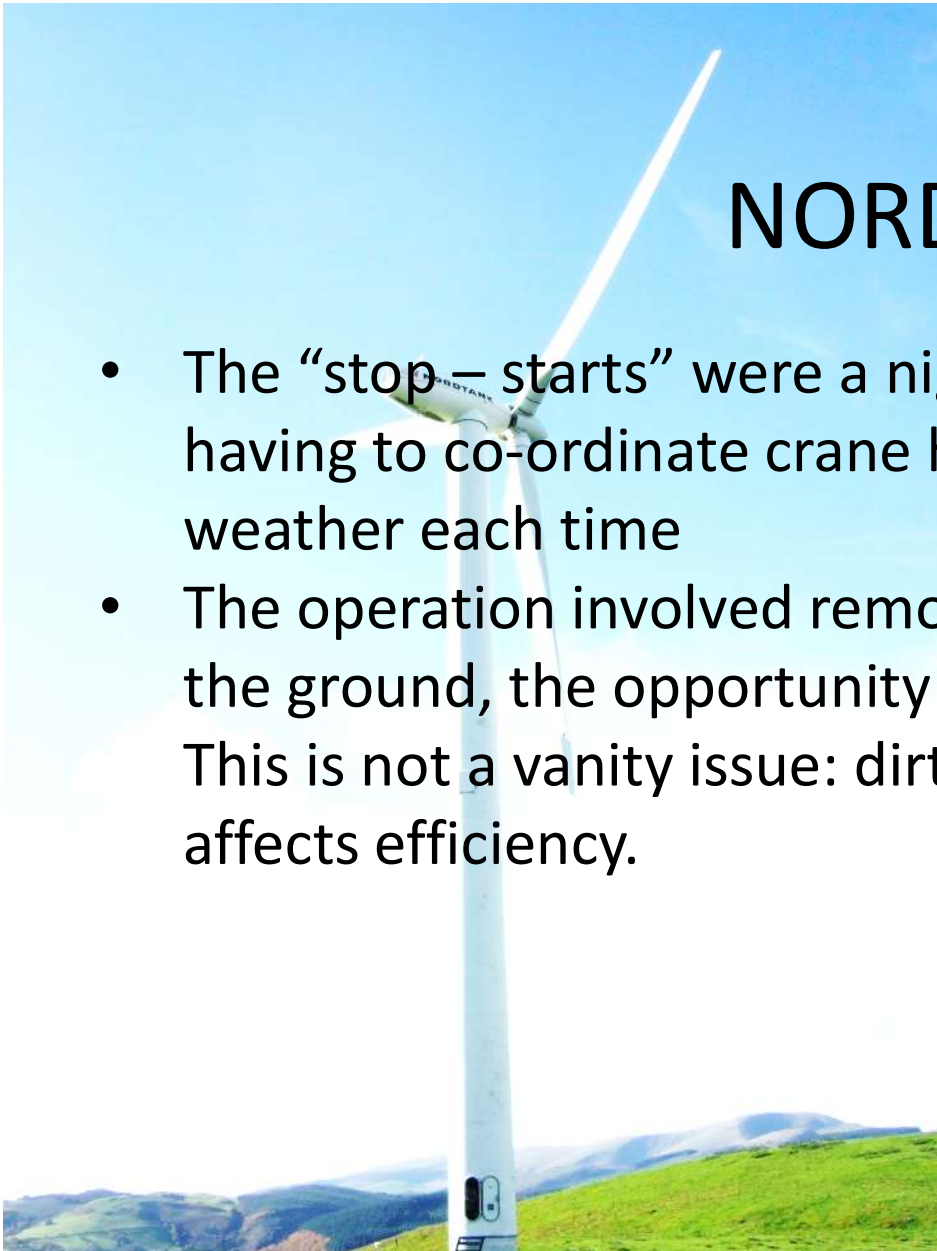
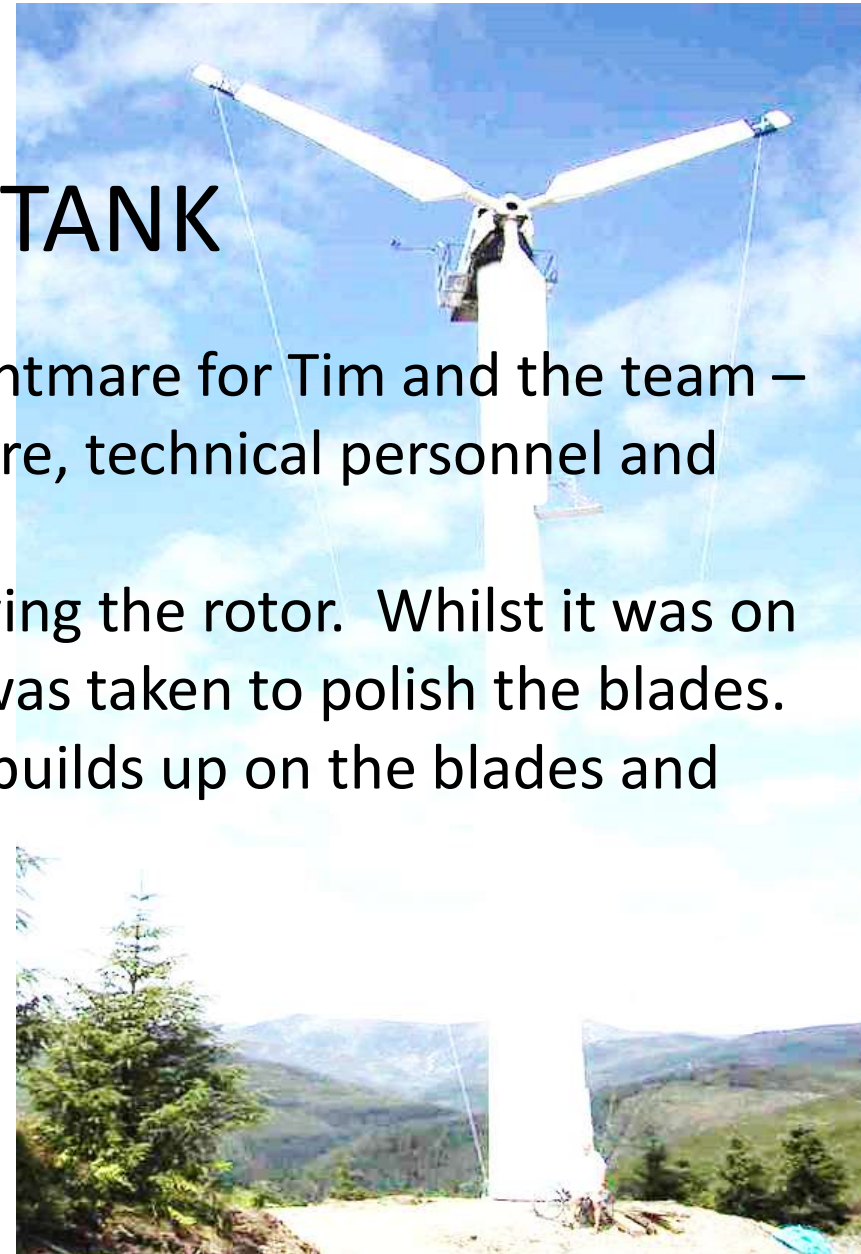
NORDTANK

- The “stop – starts” were a nightmare for Tim and the team – having to co-ordinate crane hire, technical personnel and weather each time
- The operation involved removing the rotor. Whilst it was on the ground, the opportunity was taken to polish the blades. This is not a vanity issue: dirt builds up on the blades and affects efficiency.
